Inspection Report

Victorian House Inspections

Building Description Report

This report is a description only report designed to outline construction materials including services used in the property

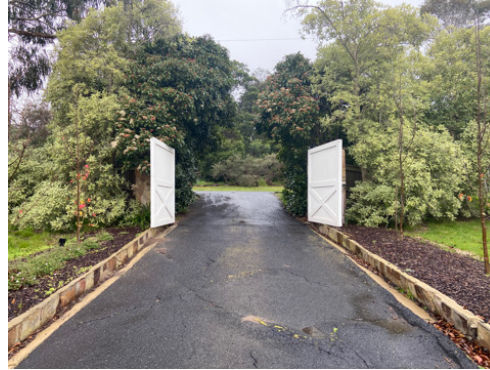
Dwelling has remote control gates installed
Fences are made of wire

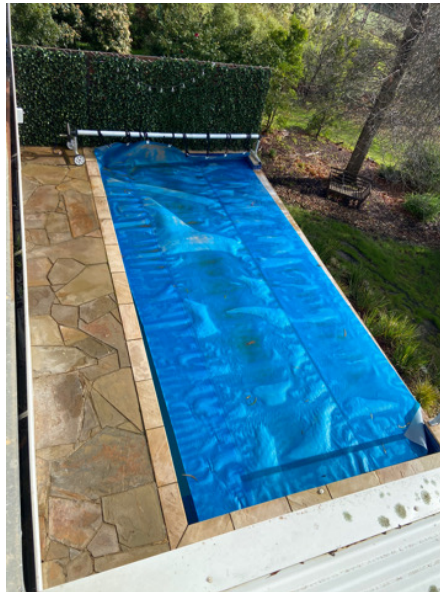
A pool is present at property

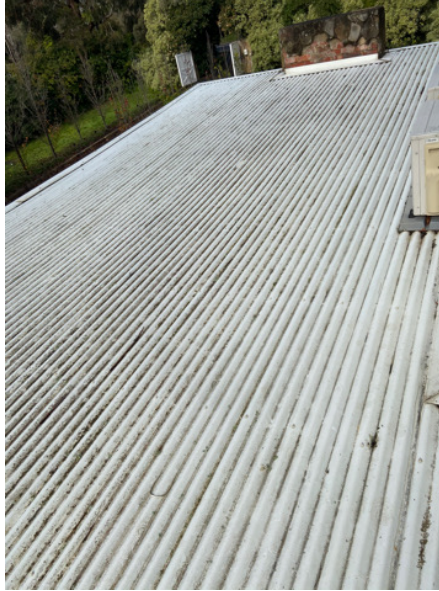
Metal roof cladding

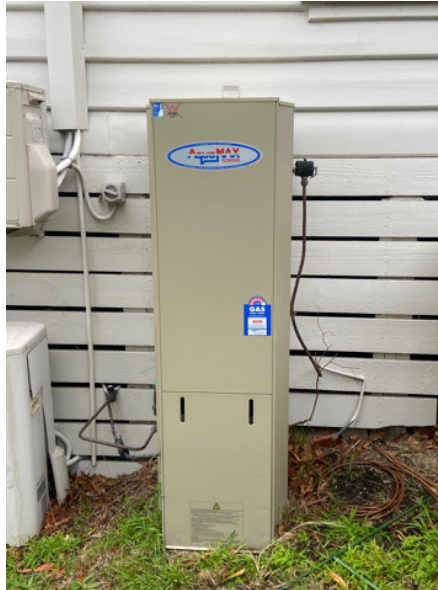
The hot water unit is located outside.

The hot water unit is a gas storage system.

The make of the hot water unit is aqua max.

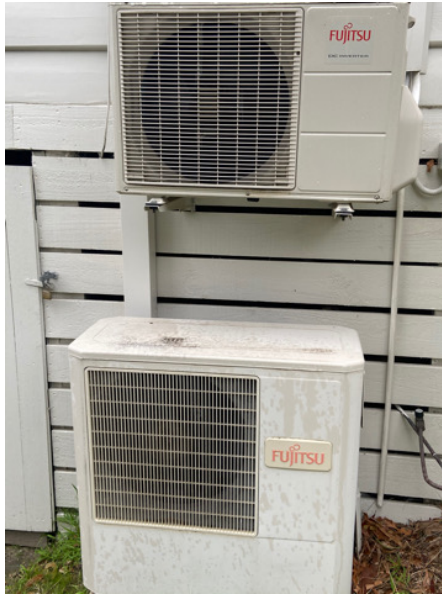
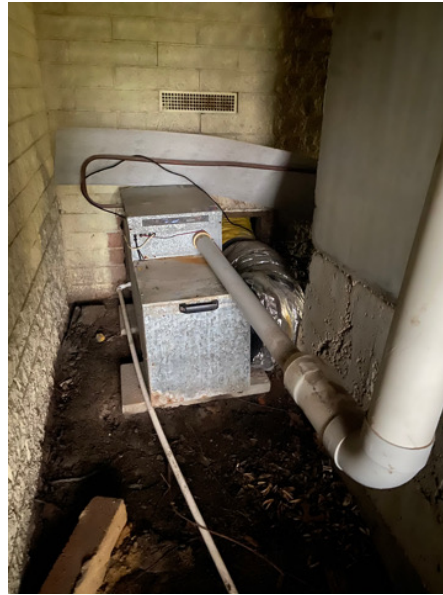
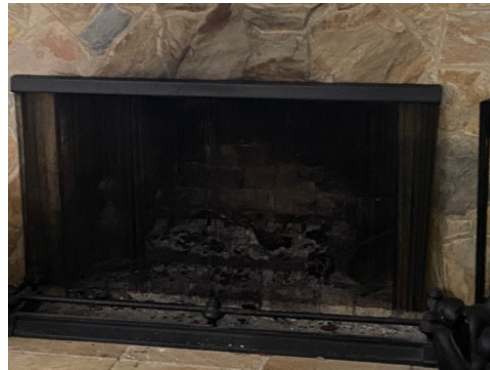
Ducted heating installed to ground floor only

Split system cooling and heating installed to lounge and all bedrooms

Fireplace installed

Split system heating and cooling installed

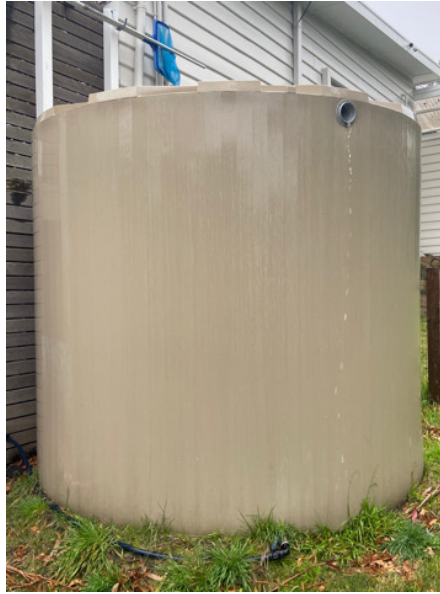
Water tank is installed

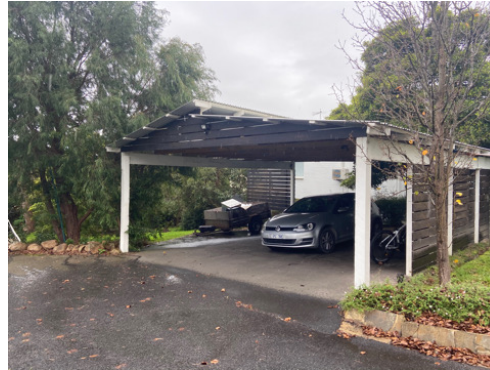
A carport is located at dwelling

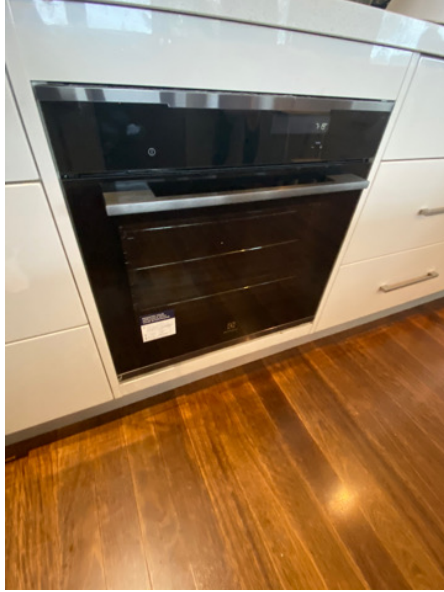
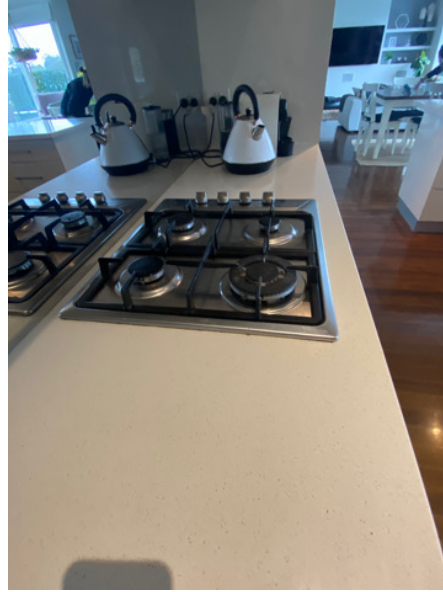
Electric oven is installed
Has hotplates are installed
Dishwasher is installed

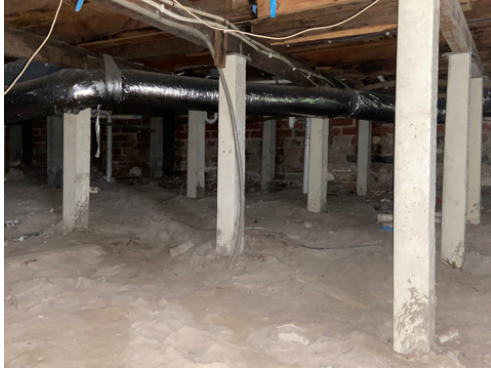
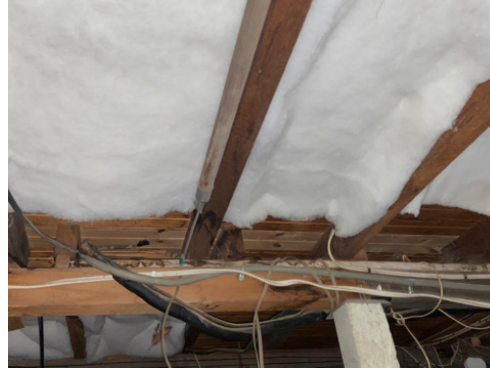
Concrete stumps installed

Gas Ducting heating installed

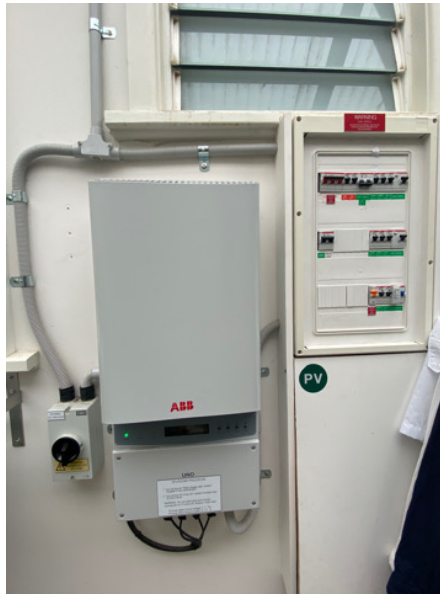
A residual current device also known as a safety switch is installed

Solar power installed
